NETWORK 2008 REVIEW: EVOLUTION, MAINTENANCE AND COLOCATIONS

Hervé FAGARD (Institut Géographique National)

Network evolutions since the last IDS workshop

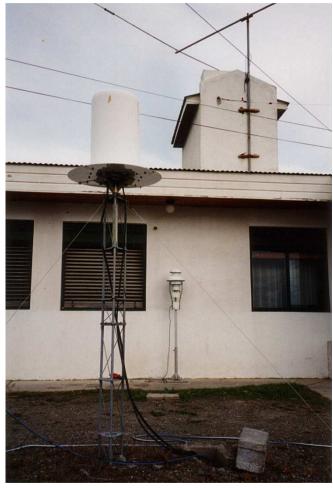
Initial installation (1987): Alcatel antenna, very loose guying

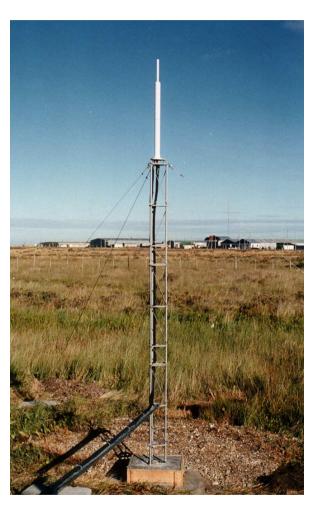
First upgrade (1995): Starec antenna, 3 m tower, good quality guying, mm-level centring and verticality

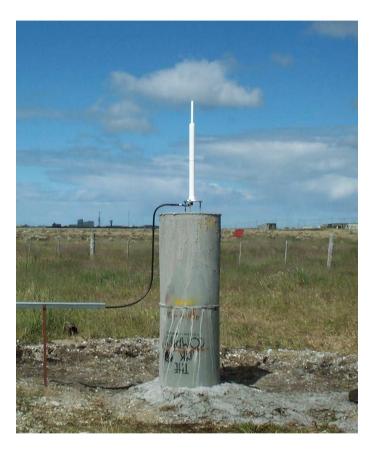
Renovation (2001): deeply anchored concrete pillar, A4 stainless steel plate. But N-type bent connector + strong constraint (due to wind) on the cables.
