# Why analysing the antenna environment?

# Reykjavik: short history

# Jiufeng: on site panoramic views

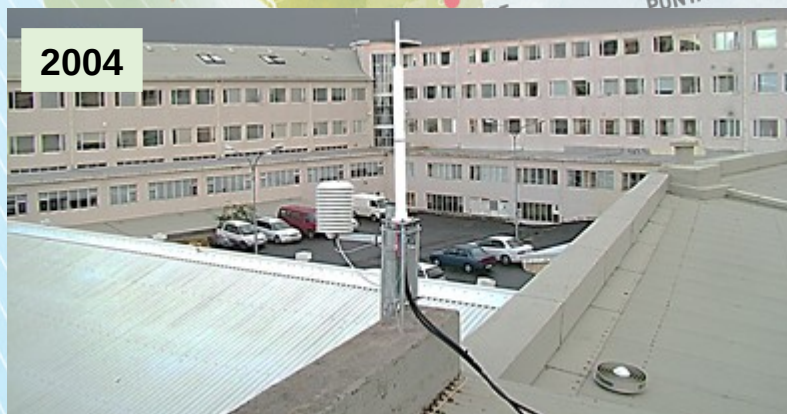
- 1990: 1st Installation in Reykjavik (REYA, then REYB)  
**Problem: RF interference in the vicinity of the antenna**
- 2004 : move on the roof of the Public Transport Admin. building (REZB)  
**Problems: Corrugated iron roof at the foot of the antenna + upcoming demolition of the building + new buildings around**
- 2020: move at Höfn (HOFC)

Many changes in Reykjavik environment, but the corrugated iron roofs are still present (images below)

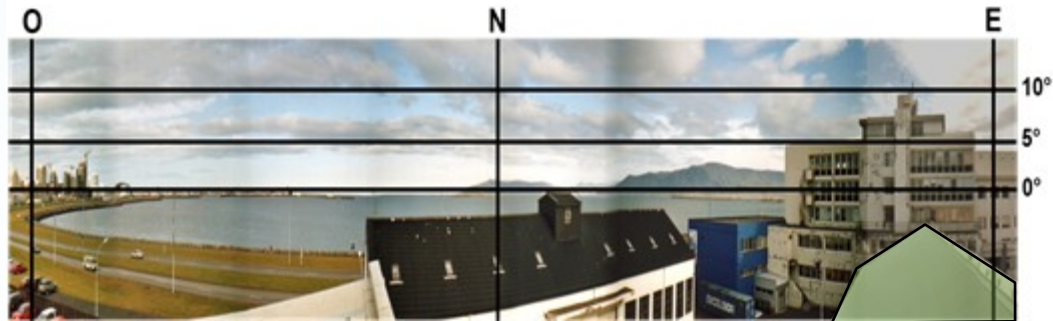
2004

# Reykjavik: evolution in the panoramic views

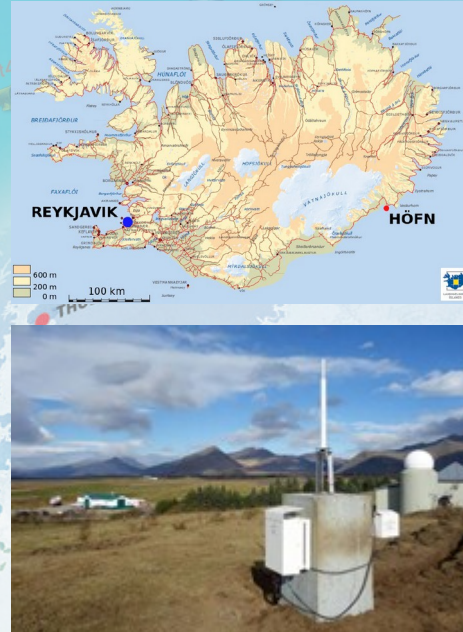
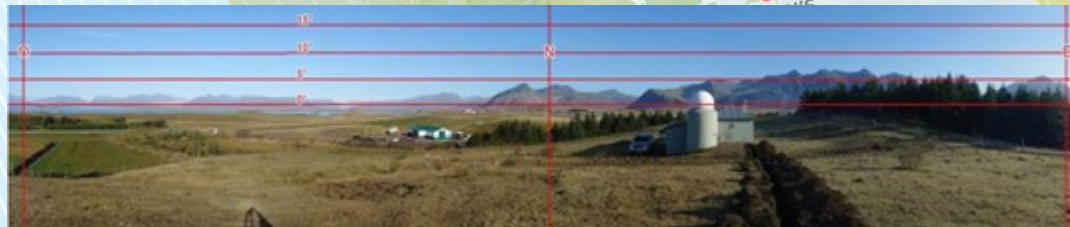
# Reykjavik to Höfn

The new site in Höfn has an excellent clearance (no mask above 7°).

The short grass at the pillar foot is optimum to avoid multipaths

The Icelandic site is now in the top 10 sites for POE RMS.

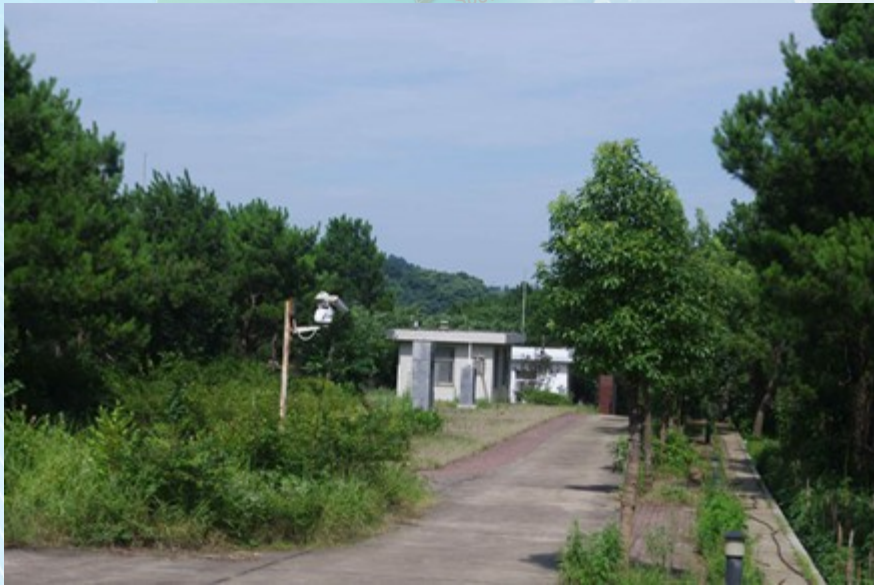
Before

# Jiufeng: trees cut off in 2012
