NETWORK 2008 REVIEW: EVOLUTION, MAINTENANCE AND COLOCATIONS

Hervé FAGARD (Institut Géographique National)

Network evolutions since the last IDS workshop

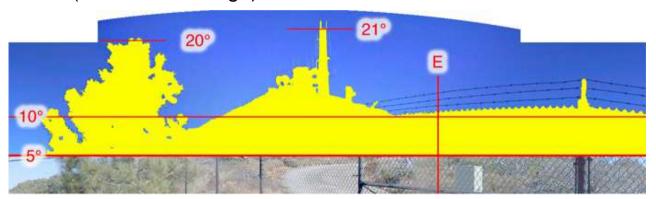
Antenna environment improvement Example 1: Monument Peak

2007 (before the change)

2008 (after the change)

Power attenuation*

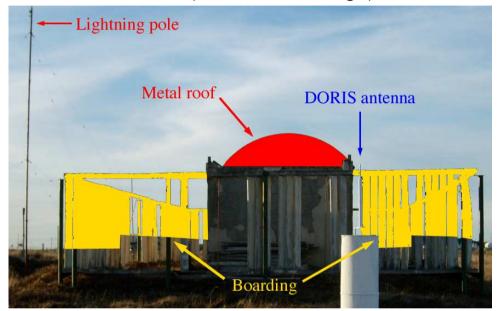
Antenna environment improvement Example 2: Rio Grande

2007 (before the change)

2008 (after the change)

Power attenuation*

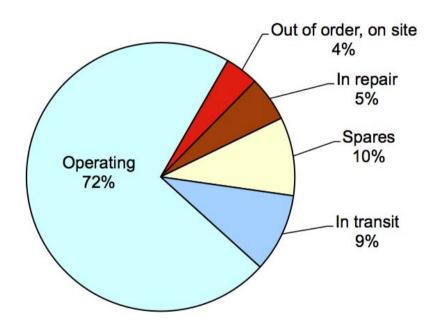
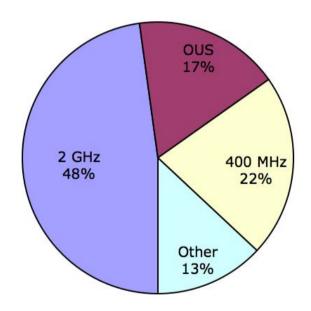
3rd generation beacons: current status & failures

Status of the 74 delivered beacons

46 beacon failures since delivery
